**BUILDING AND INFRA-STRUCTURAL DESIGN AND FACILITIES FOR  
THE DISABLED**

**A project report submitted in partial fulfilment of the  
requirements for the award of the degree of  
Bachelor (Hons.) of Quantity Surveying**

**Faculty of Engineering and Science  
Universiti Tunku Abdul Rahman**

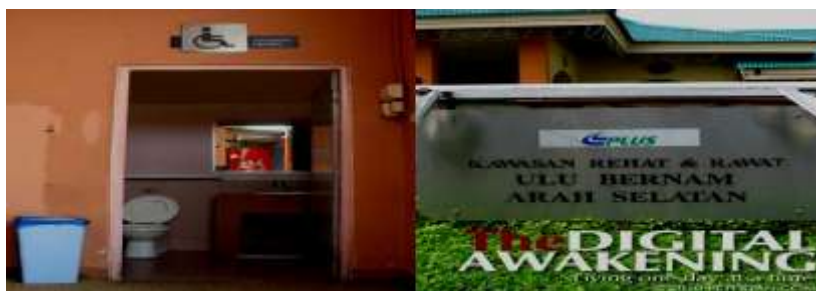
In addition, Peter Gabriel Tan said the toilets at RSA have good aesthetic values but they lack disability friendly. He finds that the toilet door is opened inwards. It is difficult for someone like him to close the door due to limited space inside to manoeuvre. Peter continued to admonish the PLUS official that all facilities provided should comply with Malaysian Standard MS 1184: Code of Practice for Access for Disable Persons to Buildings. (Source: Peter Gabriel Tan, 2010)

Figure 1 Toilet for disabled at Ulu Bernam RSA Southbound  
(Source: Peter Gabriel Tan, 2010)

The establishment of Malaysia Standard is not supposed to be treated as guidelines but an agreement that is to be enforced. Every code provided inside the Malaysian Standard serves its own purposed. From an article, it shows the local authorities had not strictly enforced the Malaysian Standard on design and facilities provided at RSA. He advised that the local authorities should conduct an evaluation to ensure all facilities at RSA are really functional.

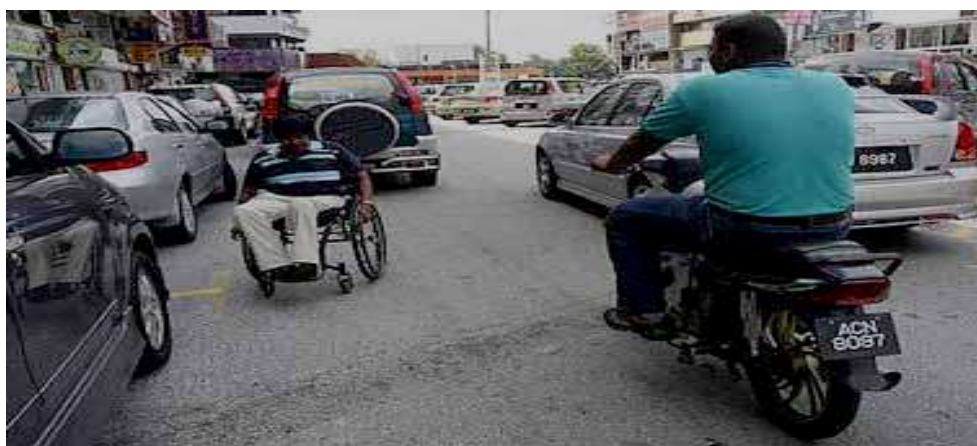
The author observed some wheelchair users moving on the road without using the pathway. This is because the kerb is high for the wheelchair users to cross over. Thomas Yeo said there are two factors to cause bad facilities for the disabled. It is vandalism and building design. Vandalism is doing something against the disabled's needs. He said he was difficult to go to a bank because buildings are not disabled-friendly. Some banks are design with high entrance and some building are without ramps.

Figure 3 Wheelchair user using the road

Lack of disabled parking lots provided at a place can cause congestion to others. Due to the inconvenience to manoeuvre, disabled people would simply park their car at side of the road. Town planner should solve this matter as fast as possible. Furthermore, building design should conform to universal design and suited for disabled needs.

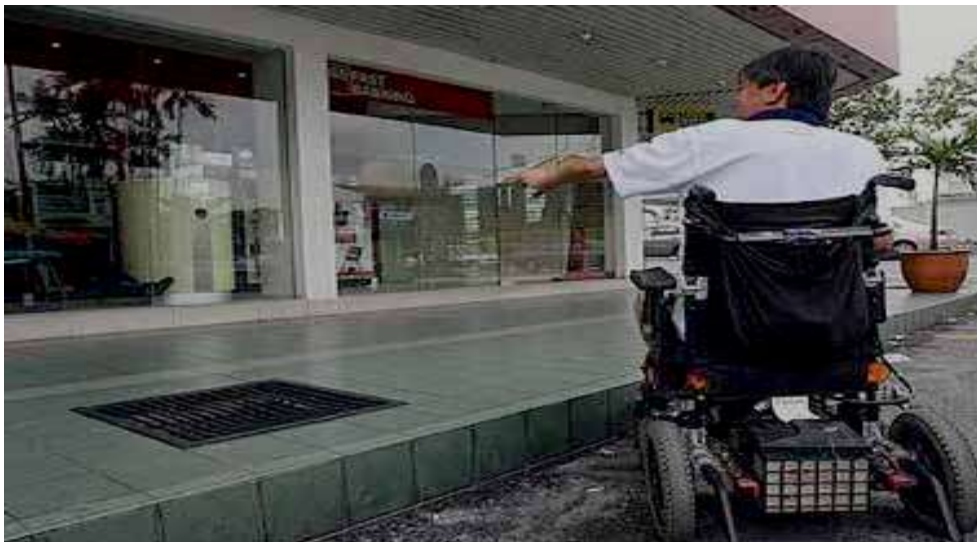
Figure 4 A wheelchair user needs help to go over the kerb  
(Source: Chirisitina Low, 2009)

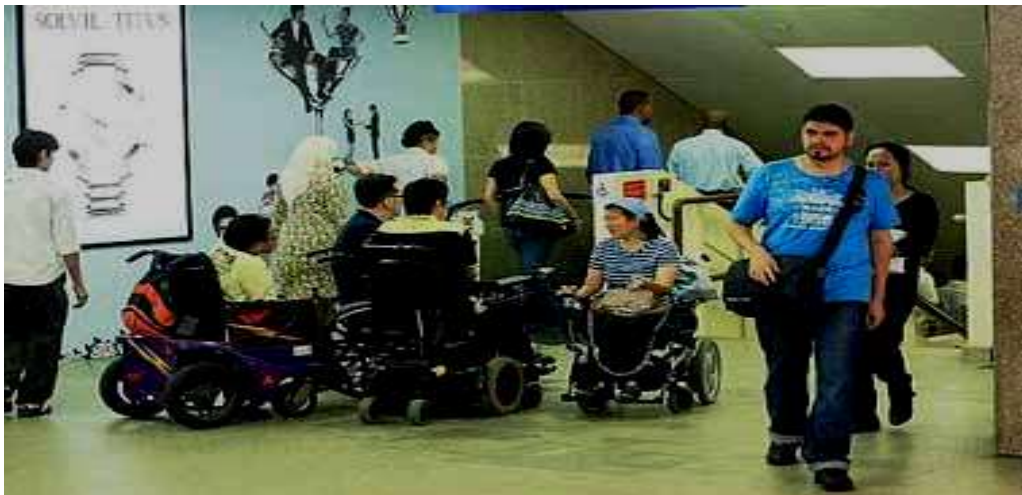
Figure 5 Disabled group are inaccessible to LRT station due to unworkable stair lift

Kenneth Thian had suggested the technician's services should engage to warrant the stair lift function at all times. All guards should have proper training to operate the stair lift and help the wheelchair users. An alternative way would be recommended to an access at linking passageway for the disabled.

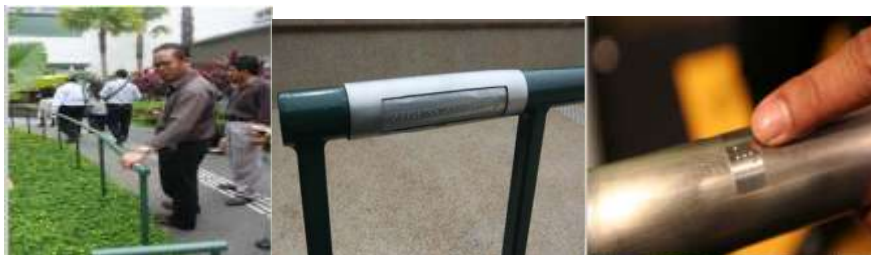
Features	<ul style="list-style-type: none"> <li>• Easy to grasp.</li> <li>• Slip-resistant.</li> <li>• Firm and comfortable grip.</li> <li>• Slide along the handrails without obstruction.</li> <li>• Small plate Braille should use at beginning and end of handrail to indicate its position for visual impaired people.</li> <li>• Painted with contrast colour to differentiate surrounding area.</li> </ul>
Appropriate diameter	<ul style="list-style-type: none"> <li>• Adults should be 30–45mm.</li> <li>• Children should be 30–35mm.</li> </ul>
Proper located height	<ul style="list-style-type: none"> <li>• Adults should be 800–900mm.</li> <li>• Children with 7 to 12 years old should be 580–700mm.</li> </ul>

Figure 24 Handrails

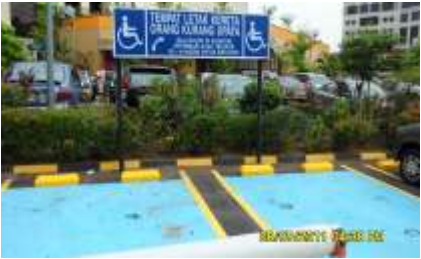
<p>Figure 37 Disabled parking lots</p>

<p><b><u>Signage</u></b></p> <ul style="list-style-type: none"> <li>• Presented to differentiate with other lots.</li> </ul>	<ul style="list-style-type: none"> <li>• Presented to avoid misuse by normal people.</li> </ul>

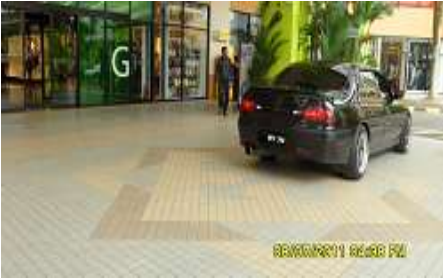
<p><b><u>Zone</u></b></p> <ul style="list-style-type: none"> <li>• Space is wide enough for users to access.</li> <li>• Located at the front of main entrance with shading cover.</li> <li>• Located at area with adequate daylight and well ventilated.</li> <li>• Guiding blocks are not</li> </ul>	<ul style="list-style-type: none"> <li>• Located at suitable area. Users can slowly move in or out from car during raining day.</li> <li>• Absent of guiding blocks; unable to guide the visual and hearing disabled people.</li> </ul>	<ul style="list-style-type: none"> <li>• Guiding blocks should be furnished.</li> <li>• Change the floor tiles or paint with sharp colour to indicate the zone.</li> </ul>

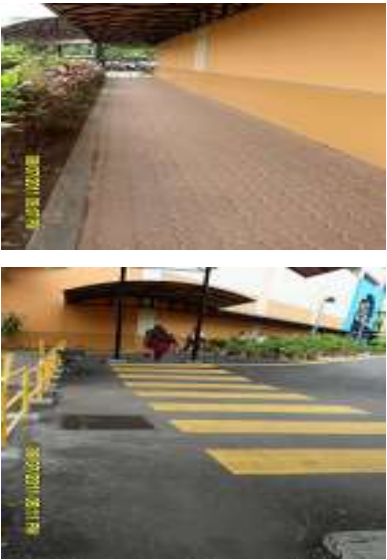
<p>Figure 40 Pathway</p>	<p><b>Pathway</b></p> <ul style="list-style-type: none"> <li>• No connected.</li> <li>• Located far from car park area.</li> <li>• Surface of floor is uneven.</li> <li>• Shading cover is presented.</li> <li>• Width of pathway is narrow.</li> <li>• Handrail is not provided.</li> <li>• Guiding blocks are not furnished.</li> <li>• Lighting is not installed.</li> </ul>	<ul style="list-style-type: none"> <li>• Located far from car park area, user's safety is secured.</li> <li>• Unacceptable floor surface presented. It will cause accidents when pedestrians pass through.</li> <li>• Shading cover is provided to protect people from exposing to sunlight and raining.</li> <li>• Pathway is not wide enough for wheelchair users to move</li> </ul>	<ul style="list-style-type: none"> <li>• Seamless connected pathway must be provided for pedestrians.</li> <li>• Proper and smooth floor finishes must be available for pedestrians.</li> <li>• Anti-slip floor tiles should be applied to prevent pedestrians from falling down during raining day.</li> <li>• Minimum width of pathway</li> </ul>

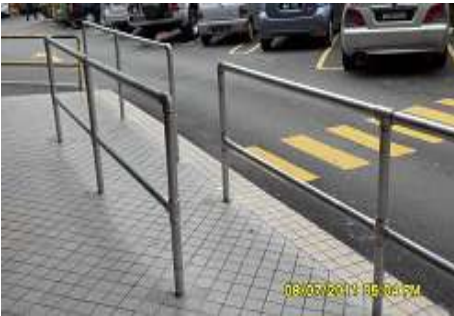
<p>Figure 41 Handrail</p>	<p><b><u>Handrails</u></b></p> <ul style="list-style-type: none"> <li>• Not painted with contrast colour to differentiate with surrounding area.</li> <li>• Surface of handrails is coarse and hard to grasp.</li> <li>• Located at improper area.</li> <li>• Installed at inappropriate height.</li> </ul>	<ul style="list-style-type: none"> <li>• People are not aware the handrail when painted in consistent colour with surrounding.</li> <li>• Coarse and sharp surface of handrail will easily harm the user's hand.</li> <li>• Simply located the handrail</li> </ul>	<ul style="list-style-type: none"> <li>• Contrast colours are recommended to use.</li> <li>• Smooth, firm and comfortable grip handrail has to be installed.</li> <li>• Locate at proper places and with appropriate height.</li> <li>• Braille type small plates</li> </ul>

Facilities	Observation	Comment	Suggestion
	<ul style="list-style-type: none"> <li>• Braille plates are not available at beginning and end of handrail.</li> </ul>	<p>will cause inaccessible by wheelchair users.</p> <ul style="list-style-type: none"> <li>• Handrail is too high; unreachable by wheelchair users.</li> <li>• Absent of Braille plate which cannot indicate its position for visual impairment people.</li> </ul>	<p>should be attached at beginning and end of handrail.</p>
<p><b><u>Staircase</u></b></p>

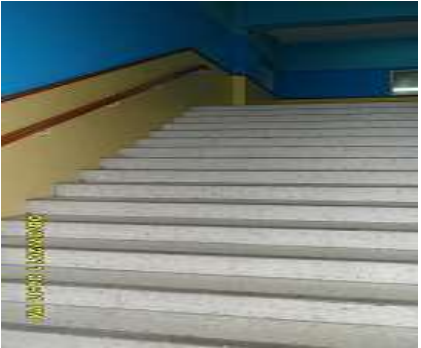
<p>Figure 42 Staircase</p>	<p><b><u>Steps</u></b></p> <ul style="list-style-type: none"> <li>• Not painted with sharp colour.</li> <li>• Absent of warning tactile.</li> </ul> <p><b><u>Nosing</u></b></p> <ul style="list-style-type: none"> <li>• Anti-slip materials are not furnished.</li> </ul>	<ul style="list-style-type: none"> <li>• Not painted with contrast colour to differentiate with flat floor.</li> <li>• Warning tactile is not present to guide the vision impaired people.</li> </ul> <ul style="list-style-type: none"> <li>• Non-slip nosing tiles are not present. Users may encounter</li> </ul>	<ul style="list-style-type: none"> <li>• Painting with protrude colours to distinguish from flat floor.</li> <li>• Hazard warning tactile paving should be furnished at top and bottom of steps.</li> <li>• Anti-slip nosing tiles should be applied.</li> </ul>

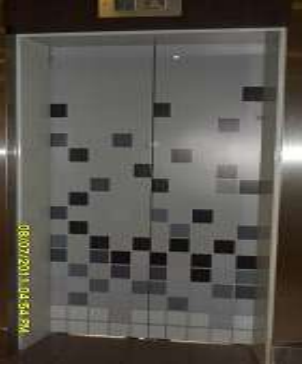
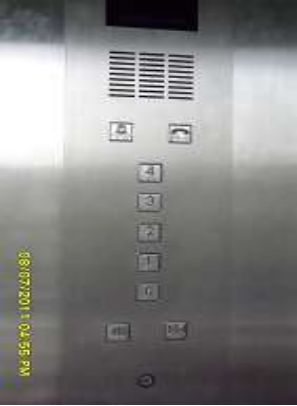
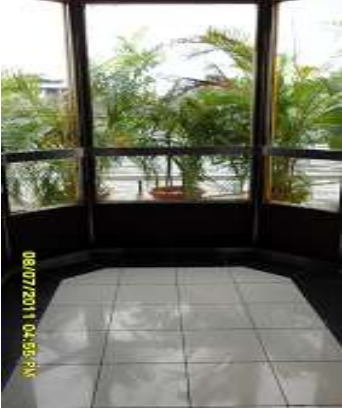
<p>enough for wheelchair users to access.</p> <ul style="list-style-type: none"> <li>Opening and closing sensors are deficient.</li> <li>Visual indicator is present outside the platform to announce the lift position.</li> </ul>	<ul style="list-style-type: none"> <li>Sound indicator is not provided to enable the open and closing sound of the lift door to be heard. Vision impaired people are not alerted whether the lift door is open or close.</li> </ul>	<ul style="list-style-type: none"> <li>Audio device is proposed to be installed at lift door to indicate whether the door is opened or closed.</li> </ul>

<p><b><u>Operation panel</u></b></p> <ul style="list-style-type: none"> <li>Braille type label buttons are available for visual impairment people.</li> <li>Single control panel is placed at proper height at right hand side of lift.</li> <li>Call-button, interphone switches, visual and voice indicators are installed inside the lift.</li> </ul>	<ul style="list-style-type: none"> <li>Only single sided control panel provided. Wheelchair users cannot reach the buttons by their heights.</li> </ul>	<ul style="list-style-type: none"> <li>Both sided control panels and one control panel at lower level should be provided inside the lift.</li> </ul>

<p>08/07/2011 04:58 PM</p> <p>Figure 43 Lift</p>	<p><b><u>Lift accessories</u></b></p> <ul style="list-style-type: none"> <li>• Sufficient space is available inside the lift.</li> <li>• Gap between floor of platform and lift is smaller.</li> <li>• Transparent glass is used as lift wall.</li> <li>• Horizontal handrail provided at three sides of interior lift.</li> <li>• Slippery floor tiles are used.</li> </ul>	<ul style="list-style-type: none"> <li>• Adequate space provided inside the lift for wheelchair users to manoeuvre.</li> <li>• Gap between floor of platform and lift is smaller. It does not create obstruction for wheelchair users to access.</li> <li>• Clear glass wall is not suitable to be lift wall. Some passengers who have acrophobia may fear to use the lift.</li> <li>• Smooth floor tiles are inappropriate to be used inside the lift. Passengers will lose their stability as the lift moves.</li> </ul>	<ul style="list-style-type: none"> <li>• A mirror wall is recommended to be provided at three sides of wall lift for passengers to know whether the door is opened or closed.</li> <li>• Anti-slip carpet is advised to use as floor finishes.</li> </ul>

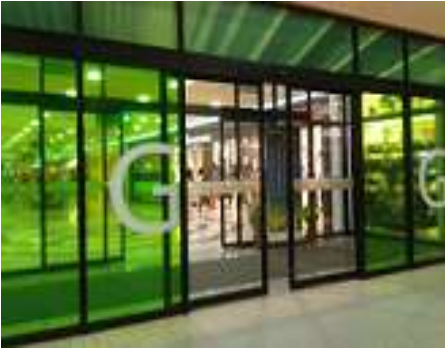
<p>Figure 44 Doorway</p>	<p><b><u>Door</u></b></p> <ul style="list-style-type: none"> <li>• Glass door is used.</li> <li>• Width of the door is wide enough for wheelchair users to access.</li> <li>• Sticker is placed on the glass to distinguish between door and wall.</li> <li>• Threshold is not required.</li> <li>• Automatic re-opening sensor is installed above the door.</li> <li>• Audio indicator and guiding block is not provided.</li> </ul>	<ul style="list-style-type: none"> <li>• Transparent glass door is used. Users can easily see things and people from the opposite side.</li> <li>• Absent of sound device and guiding blocks to guide the visual and hearing disabled people.</li> </ul>	<ul style="list-style-type: none"> <li>• Sound indicator and guiding blocks should be provided.</li> </ul>
<p><b><u>Signage</u></b></p>

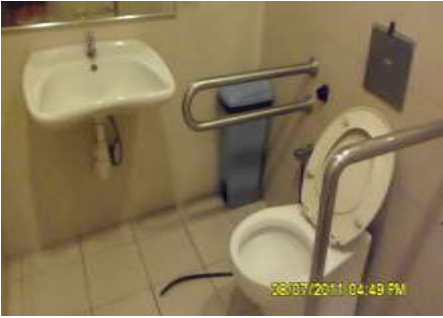
<p>Figure 46 Toilet Furniture</p>	<p><b><u>Toilet furniture</u></b></p> <ul style="list-style-type: none"> <li>• Sufficient space provided.</li> <li>• Basin and water closet are provided at suitable height.</li> <li>• Handrails are installed for disabled people.</li> <li>• Mirror is installed above the basin.</li> <li>• Tissue holder and tissues are not provided.</li> <li>• Emergency fittings are not</li> </ul>	<ul style="list-style-type: none"> <li>• Adequate space provided for wheelchair users to manoeuvre.</li> <li>• Braille type small plates are no attached at surface of handrail to tell the visual impairment people the location of toilet furniture.</li> <li>• Tissue holder and tissues are not provided. They are basic</li> </ul>	<ul style="list-style-type: none"> <li>• Braille type small plates should be attached at surface of handrails.</li> <li>• Tissues holder and tissues must be supplied at all times.</li> <li>• Emergency fittings such as alarm, cord, siren and light beacon should be installed in toilet.</li> </ul>

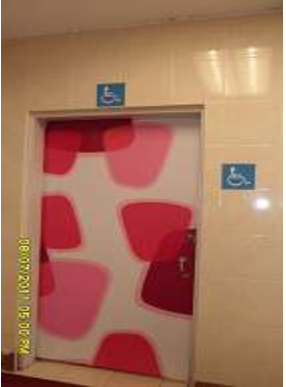
<p data-bbox="188 772 472 804">Figure 47 Toilet Door</p>	<p data-bbox="698 368 824 400">provided.</p> <ul data-bbox="651 424 1099 628" style="list-style-type: none"> <li data-bbox="651 424 1099 512">• Sufficient door width provided.</li> <li data-bbox="651 536 1099 568">• Wallpaper is stacked at door.</li> <li data-bbox="651 592 1099 624">• Signage is present.</li> </ul>	<p data-bbox="1173 368 1572 456">things which should be supplied.</p> <ul data-bbox="1126 480 1572 959" style="list-style-type: none"> <li data-bbox="1126 480 1572 679">• Emergency fittings are not available; people cannot discover any accident that happens inside the toilet.</li> <li data-bbox="1126 703 1572 791">• Door is wide enough for wheelchair users to access.</li> <li data-bbox="1126 815 1572 959">• Wallpaper is stacked at the door to distinguish between the door and wall.</li> </ul>

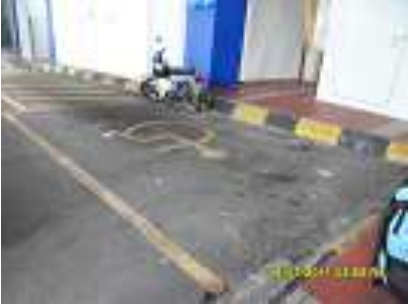
<p>Figure 49 Parking lots</p>	<p><b><u>Parking lots</u></b></p> <ul style="list-style-type: none"> <li>• Adequate space provided for users to park in the car.</li> <li>• Insufficient space provided between two parking lots.</li> <li>• Located near to lift.</li> <li>• Placed proximity to bus stop.</li> <li>• No levelled with anti-resistance.</li> <li>• No painted with contrast colour.</li> </ul>	<ul style="list-style-type: none"> <li>• Even the size of parking lot is big enough for car to park in, but there is insufficient space provided between two parking lots for wheelchair users to manoeuver.</li> <li>• The air surrounding the bus stop is polluted. The place is unsuitable for disabled people to access.</li> <li>• Users cannot recognise the place if the parking lots no paint with bright colour.</li> </ul>	<ul style="list-style-type: none"> <li>• Accessible area among two parking lots should be provided for users to access.</li> <li>• Parking lots should be properly arranged and placed at appropriate area.</li> <li>• Anti-slip material must be furnished at parking lots and accessible area.</li> <li>• Sharp colour should be applied at parking lots.</li> </ul>

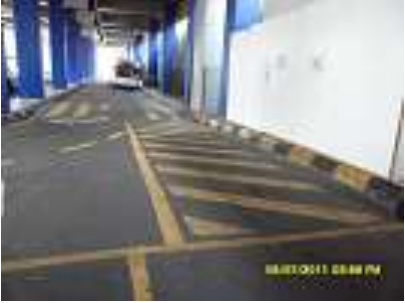
<p>Figure 50 Picking up and dropping off zone</p>	<p><b><u>Zone</u></b></p> <ul style="list-style-type: none"> <li>Improper furnished the zone.</li> <li>Absent of signage.</li> <li>Placed behind the parking lots.</li> <li>Guiding blocks are not furnished.</li> </ul>	<ul style="list-style-type: none"> <li>Inappropriate positioned of zone; users will ignore to use it.</li> <li>Absent of signage; people will misuse the area as parking lots.</li> <li>Located behind the parking lots. Users' safety is being threatened when the car reverses.</li> <li>Absent of guiding blocks; unable to guide the visual or hearing disabled people.</li> </ul>	<ul style="list-style-type: none"> <li>Zone should be located at accessible area.</li> <li>Signage must be presented to indicate people.</li> <li>Guiding blocks must be available for pedestrian.</li> </ul>

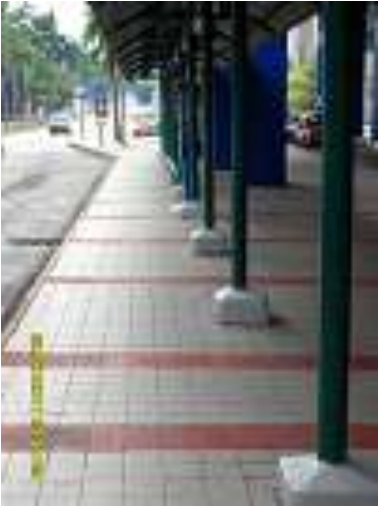
<p>Figure 51 Pathway</p>	<p><b><u>Pathway</u></b></p> <ul style="list-style-type: none"> <li>• No connected.</li> <li>• Shading cover is presented.</li> <li>• Many columns are erected at center of pathway.</li> <li>• Bus stop is built at center of pathway.</li> <li>• Insufficient space is allowed for wheelchair users to manoeuver.</li> <li>• Lighting is not installed.</li> <li>• Handrail is not provided.</li> <li>• Guiding blocks are not furnished.</li> </ul>	<ul style="list-style-type: none"> <li>• Shading cover is provided to protect people from exposing to sunlight and raining.</li> <li>• Columns are formed an obstruction for users.</li> <li>• Bus stop is created an impediment for users.</li> <li>• Pathway is narrow; unable for users to access.</li> <li>• No lighting provided, pedestrians' safety are being threatened.</li> <li>• Handrail is not provided to assist pedestrians.</li> <li>• Guiding blocks are not presented to indicate the direction.</li> </ul>	<ul style="list-style-type: none"> <li>• Seamless connected pathway must be provided for pedestrians.</li> <li>• Columns must be removed or placed at side of pathway.</li> <li>• Bus stop is recommended to build at particular place.</li> <li>• Sufficient space must be at least enable to allow for users to access.</li> <li>• Adequate lighting must be supplied to enhance user's well-being.</li> <li>• Handrail should be installed at both sides of pathway.</li> <li>• Guiding block should be furnished to lead the users.</li> </ul>

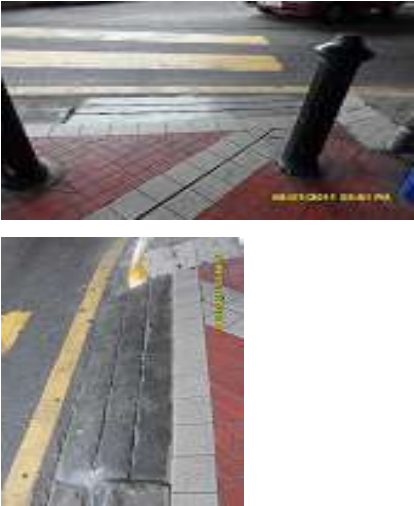
<p>Figure 52 Kerb ramp</p>	<p><b><u>Kerb ramp</u></b></p> <ul style="list-style-type: none"> <li>• Returned kerb ramp is presented.</li> <li>• Located at place out of usual line of pedestrian flow.</li> <li>• Placed at area which avoid from water accumulates.</li> <li>• A post stands at among of ramp.</li> <li>• Indent lines are presented.</li> <li>• No painted with sharp colours.</li> <li>• Absent of guiding blocks.</li> </ul>	<ul style="list-style-type: none"> <li>• Improper placed the post; ramp becomes useless.</li> <li>• Indent lines are used as slip-resistant purpose.</li> <li>• Ramp no painted with contrast colours; people may encounter the danger of falling down.</li> <li>• Guiding blocks are not presented to warn the users.</li> </ul>	<ul style="list-style-type: none"> <li>• Proper design should be planed before building.</li> <li>• A post should be removed.</li> <li>• Paints the kerb ramp with contrast colours to distinguish the ramp and floor area.</li> <li>• Guiding blocks should be furnished to assist the vision impaired people.</li> </ul>

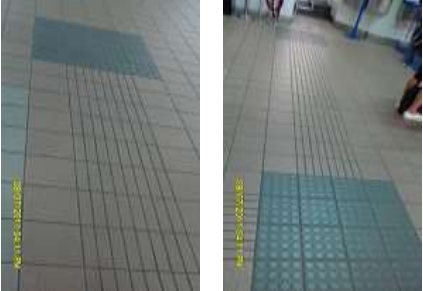
<p>Figure 53 Guiding blocks and lines</p>	<p>light.</p>	<p>awareness.</p>	
<p><b><u>Handrails</u></b></p>

<p><b><u>Guiding blocks</u></b></p>	<p><b><u>Guiding blocks</u></b></p> <ul style="list-style-type: none"> <li>• Inappropriate placed of guiding blocks.</li> <li>• Unconnected guiding blocks presented.</li> <li>• Colour of guiding blocks is</li> </ul>	<ul style="list-style-type: none"> <li>• Improper placed of guiding blocks; indicate users in wrong direction.</li> <li>• Colour of guiding blocks is light; unable to attract users'</li> </ul>	<ul style="list-style-type: none"> <li>• Systematic guiding blocks should be provided to guide the users.</li> <li>• Guiding blocks should be furnished with sharp colour.</li> </ul>

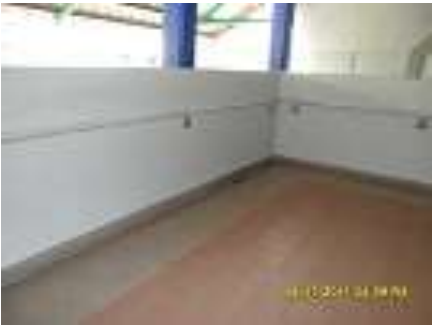
<p>Figure 54 Handrail</p>	<p><b><u>Handrail</u></b></p> <ul style="list-style-type: none"> <li>• Firm and easy to grasp.</li> <li>• Installed at corner.</li> <li>• Installed at proper height.</li> <li>• Unconnected handrail is presented.</li> <li>• Colour of handrail is same with the wall.</li> <li>• Absent of Braille type small plate.</li> </ul>	<ul style="list-style-type: none"> <li>• Unconnected positioned of handrail; unable to assist people.</li> <li>• Similar colour used at handrail and wall; people cannot recognise the handrail position.</li> <li>• Braille type small plates are not attached at beginning and end of the handrail; unable to</li> </ul>	<ul style="list-style-type: none"> <li>• Connected handrail is recommended to install.</li> <li>• Contrast colours must be used to differentiate between the wall and handrail.</li> <li>• Braille type small plates should be presented at beginning and end of handrails to indicate its position.</li> </ul>

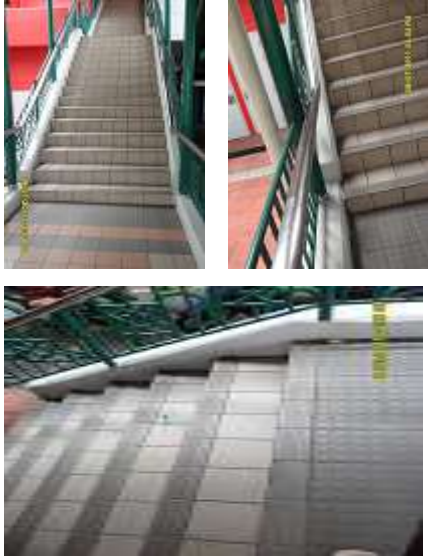
<p data-bbox="185 1054 434 1083">Figure 55 Staircase</p>	<p data-bbox="651 427 730 456"><b><u>Steps</u></b></p> <ul data-bbox="651 483 1099 687" style="list-style-type: none"> <li>• Risers and treads are standardised built up.</li> <li>• Absent of warning tactile.</li> <li>• No painted with sharp colour.</li> </ul> <p data-bbox="651 874 752 903"><b><u>Nosing</u></b></p> <ul data-bbox="651 930 1070 959" style="list-style-type: none"> <li>• Protrude nosing tiles is used.</li> </ul> <p data-bbox="651 994 792 1023"><b><u>Handrails</u></b></p> <ul data-bbox="651 1050 1025 1198" style="list-style-type: none"> <li>• Presented at both sides.</li> <li>• Located at proper height.</li> <li>• Easy to grip.</li> </ul> <p data-bbox="651 1225 775 1254"><b><u>Landing</u></b></p> <ul data-bbox="651 1281 1084 1310" style="list-style-type: none"> <li>• Guiding blocks are furnished.</li> </ul>	<ul data-bbox="1126 483 1574 791" style="list-style-type: none"> <li>• Warning tactile is not present to guide the vision impaired people.</li> <li>• Not painted with contrast colour to differentiate with flat floor.</li> </ul>	<ul data-bbox="1599 483 2024 847" style="list-style-type: none"> <li>• Hazard warning tactile paving is recommended to furnish at top and bottoms of steps.</li> <li>• Painting with protrude colours to distinguish from flat floor.</li> </ul>

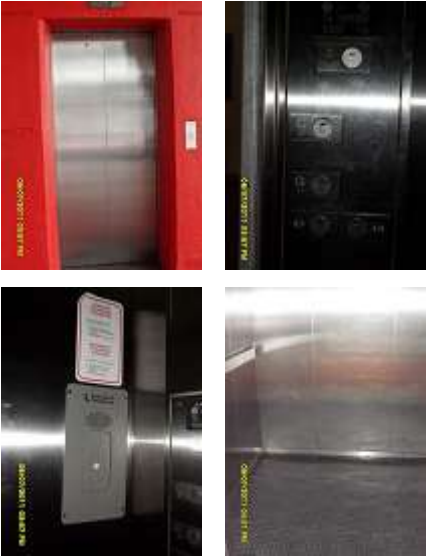
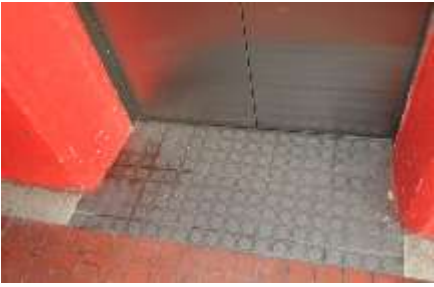
<p><b><u>Lift doors</u></b></p> <ul style="list-style-type: none"> <li>• Located at accessible area.</li> <li>• Lift door is wide enough for wheelchair users to access.</li> <li>• Lift door and wall are showed in contrast colours to differentiate with each other.</li> <li>• Automatic re-opening sensor is not installed between the lift doors.</li> </ul>	<ul style="list-style-type: none"> <li>• Absent of automatic re-opening sensor which cannot trap the passengers between the door panels.</li> </ul>	<ul style="list-style-type: none"> <li>• Photo-electric sensor has to be installed to detect the passengers and control the door.</li> </ul>

<p>Figure 56 Lift</p>	<p><b><u>Operation panel</u></b></p> <ul style="list-style-type: none"> <li>• Call-button, operating panel, interphone switches are presented at proper height.</li> <li>• Braille type push operating buttons are used.</li> <li>• Internal operating panel is provided at left-side wall</li> </ul>	<ul style="list-style-type: none"> <li>• Only single sided control panel provided. Wheelchair users cannot reach the buttons by their heights.</li> <li>• Visual and hearing disabled people are required the visual and voice indicators have</li> </ul>	<ul style="list-style-type: none"> <li>• Both sided control panels and one control panel at lower level should be provided inside the lift.</li> <li>• Visual and voice indicators should be installed at inside and outside the lift to assist</li> </ul>

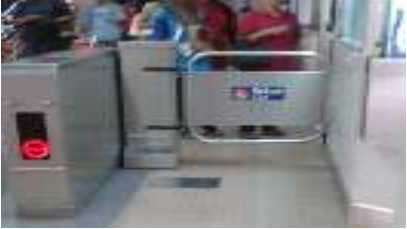
<p><b><u>Doorway</u></b></p>	<p><b><u>Door</u></b></p> <ul style="list-style-type: none"> <li>• Door is wide enough for wheelchair users to access.</li> <li>• Manual opening type door is</li> </ul>	<ul style="list-style-type: none"> <li>• Manual opening door is used. It makes difficulties for wheelchair users when they</li> </ul>	<ul style="list-style-type: none"> <li>• Automatic re-opening sensor door is recommended to install.</li> </ul>

<p>Figure 57 Doorway for disabled to access</p>	<p>used.</p> <ul style="list-style-type: none"> <li>• Similar colour is used at door and other equipments.</li> </ul>	<p>access.</p> <ul style="list-style-type: none"> <li>• Same colour is used at door and other equipments; users are hard to recognise it.</li> </ul>	<ul style="list-style-type: none"> <li>• Contrast colour should be used to differentiate between door and other equipments.</li> </ul>
<p><b>Signage</b></p>

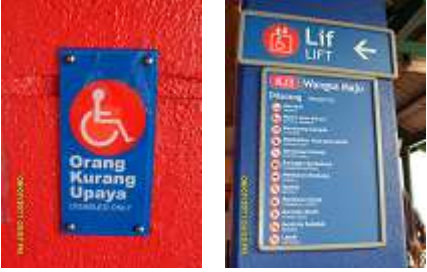
<p>Figure 58 Signage</p>	<p><b>Signage</b></p> <ul style="list-style-type: none"> <li>• The types and location of available facilities are clearly indicated.</li> <li>• Visible, clear simple and easy to read and understand.</li> <li>• Contrast colours are used to discriminate between symbol and background.</li> <li>• Placed at main entrance.</li> <li>• Absent of Braille type signage.</li> </ul>	<ul style="list-style-type: none"> <li>• Figures of signage are presented in smaller size. Visual problems users are hard to read.</li> <li>• Absent of Braille type signage; cannot guide the visual impairment people.</li> </ul>	<ul style="list-style-type: none"> <li>• Figures and symbol at signage should be written in bigger size.</li> <li>• Braille type signage is suggested to provide.</li> </ul>

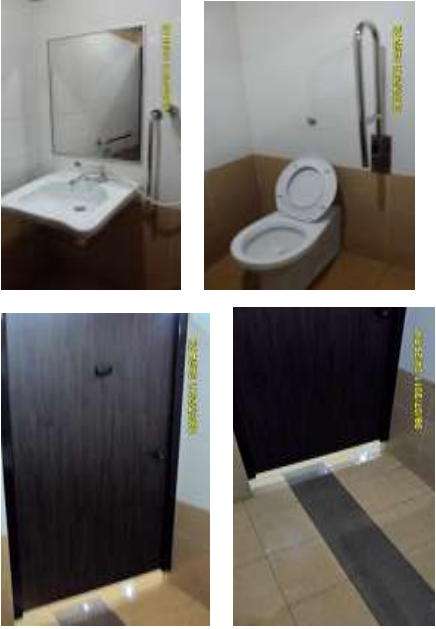
<p>Figure 59 Toilet</p>	<p><b><u>Toilet furniture</u></b></p> <ul style="list-style-type: none"> <li>• Sufficient space provided.</li> <li>• Basin and water closet are provided at suitable height.</li> <li>• Handrails are installed for disabled people.</li> <li>• Mirror is installed above the basin.</li> <li>• Toilet door is wide enough for wheelchair users to access.</li> <li>• Tissue holder and tissues are not available.</li> <li>• Emergency fittings are not installed.</li> <li>• Braille type small plates are not attached at surface of handrails.</li> </ul>	<ul style="list-style-type: none"> <li>• Tissue holder and tissues are not provided. They are basic things which should be supplied.</li> <li>• Emergency fittings are not available; people cannot discover any accident that happens inside the toilet.</li> <li>• Braille type small plates are no attached at surface of handrail to tell the visual impairment people the location of toilet furniture.</li> </ul>	<ul style="list-style-type: none"> <li>• Tissues holder and tissues must be supplied at all times.</li> <li>• Emergency fittings such as alarm, cord, siren and light beacon should be installed in toilet.</li> <li>• Braille type small plates should be attached at surface of handrails.</li> </ul>
