**A STUDY OF RETROFIT STRITAGIES ON A
HISTORIC BUILDING IN CHINA TOWARDS
SUSTAINABLE DEVELOPMENT**

**A project report submitted in partial fulfilment of the
requirements for the award of Master of Sustainable Construction Management**

Faculty of Engineering and Green Technology

April 2023

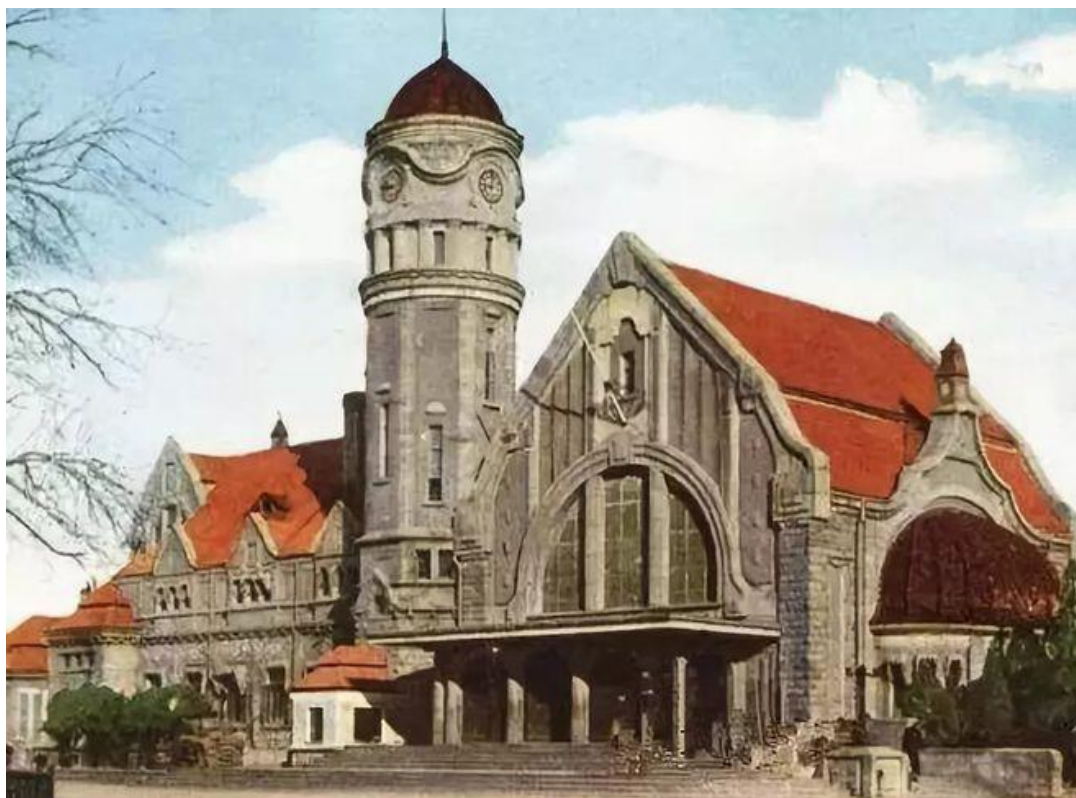
Figure1.1 The old Jinan train station
(Source:<https://www.163.com/dy/article/DR23OP6U0521C7DD.html>)

varying degrees, even destroyed. The demolition and reconstruction of the old Jinan Railway Station, also known as Jinan Station of Jinpu Railway, is an extremely painful example. The old Jinan Railway Station was once one of the largest railway stations in East Asia. (Petra Kolonko, 2013) It was designed by the German architect Herman Fisher in the late nineteenth and early twentieth centuries. Although it has unique architectural style, it was not certificated as historic building. In 1992, despite much opposition, the Jinan municipal government demolished the beautiful and meaningful building. Now, people can only see it from the website and from old photos.

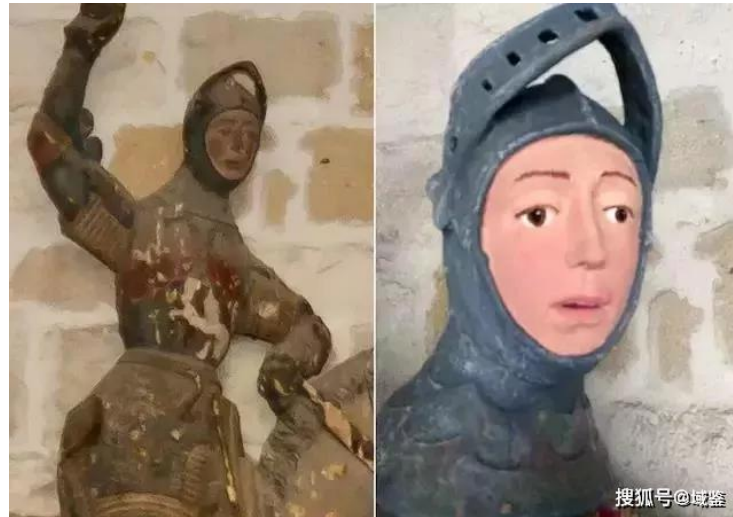
to the building during the repair process, and not to turn a good thing into a bad thing.(Zhao,2002) In a Romanesque church in the northern Spanish town of Estella, a relief statue of “Saint George on Horseback” handed down from the 16th century, because of disrepair, the priest of the church invited a person to restore the statue. Below is a comparison of before and after repairs.

Figure1.2 Comparison of before and after repairs(Source: https://www.sohu.com/a/352408037_99992249)

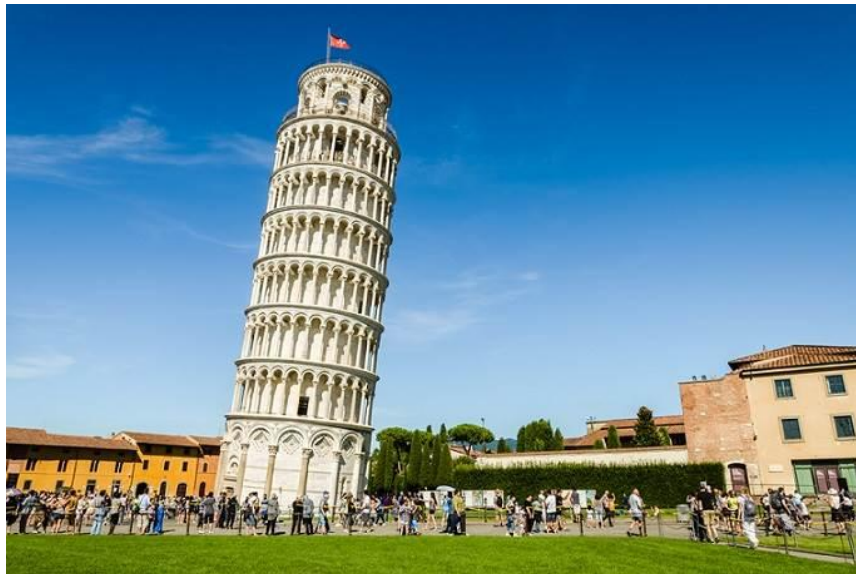
Common damage to the foundations of historic buildings is mainly settlement and fragmentation. The reason is mainly due to the change of the bearing capacity of the

foundation, the influence of groundwater, the growth of tree roots, the damage of underground pipelines, and the damage of external forces. When repairing, it is necessary to first identify the reasons and eliminate these adverse effects. For foundation repair and reinforcement, common methods include compaction grouting and pressed pile by anchor rod. When compaction grouting is adopted, the slurry should be filtered, and the diameter of the solid particles should not exceed 0.1mm. The slurry should have good fluidity, and its diffusion radius should meet the design requirements. The one that needs to be paid attention to when using pressed piles is that pile pressing should be completed at one time. When a stop is required, the tip of the pile should stay in the soft soil layer, and the rest time should not exceed 24 hours. (Ministry of Housing and Urban-Rural Development of PRC, 2019) During the repair process, the original structure and walls must be supported and reinforced, and if necessary, calculations and design plans should be made to ensure safe construction.

Figure 2.1 An example of subsidence asymmetrical of foundation
(Source: <https://www.nuestro.cl/5-facts-you-didnt-know-about-the-leaning-tower-of-pisa/>)

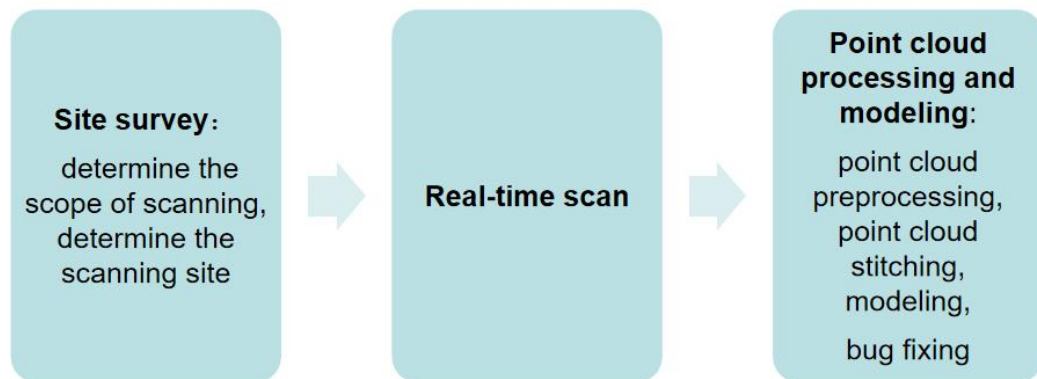
The traditional 3D data acquisition methods mainly include the method of single-point acquisition of 3D coordinates, close-range photogrammetry, aerial photogrammetry, etc. The former such as GPS high-precision positioning, 3D coordinate measuring machine, total station system, etc. There is a big difference between 3D laser scanning technology and traditional technical means. This technology breaks through the traditional single-point measurement method and can quickly obtain massive 3D coordinate data on the surface of objects. These 3D coordinate data are also called point clouds. The whole process of 3D laser scanning measurement mainly includes three steps: site survey and fixed point,

implementation scanning, point cloud data processing and modeling (as shown in the figure). Each step has its own implementation requirements or detailed process.

Figure 2.2: The process of using laser scanning

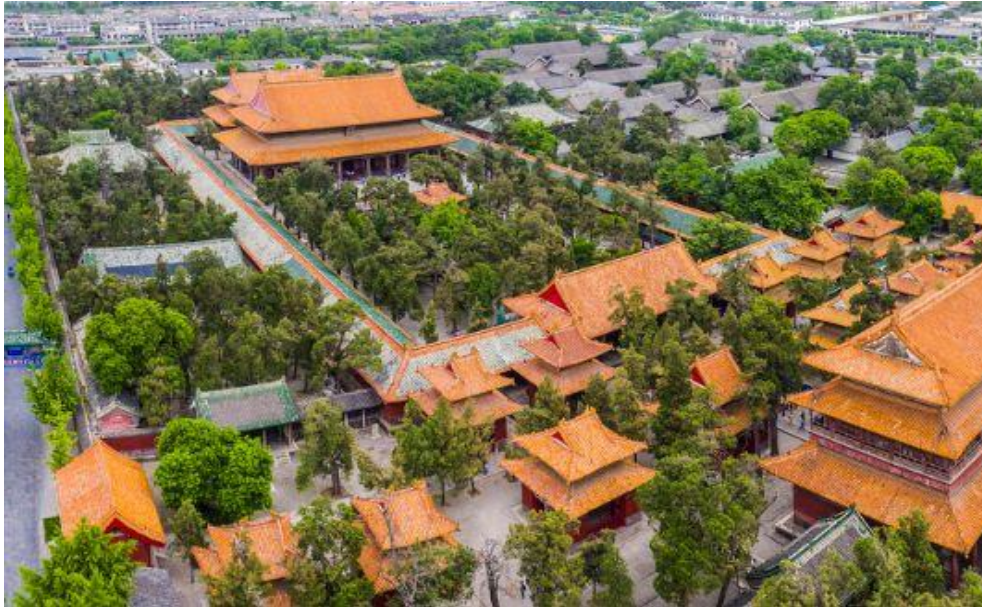
Name	Temple and Cemetery of Confucius and the Kong Family Mansion
Location	Qufu City, Shandong Province, China
Completion time	478BC----the earliest recorded More details are provided in report.
Building material	Wood, masonry
The original purpose of the building	Residences, sacrifices, tombs
The value of the building	
Protected list: State Priority Protected Sites in 1961; United Nations Educational, Scientific, and Cultural Organization (UNESCO), World Heritage List (https://whc.unesco.org/en/list/704/)	
The main current use of the building: Tourist attractions	
Social benefits and others: A representative of oriental architectural techniques, and has a deep historical connotation.

Figure3.3: Temple and Cemetery of Confucius and the Kong Family Mansion
(Source:http://k.sina.com.cn/article_7042248789_p1a3c0305500100k1ot.html#/)

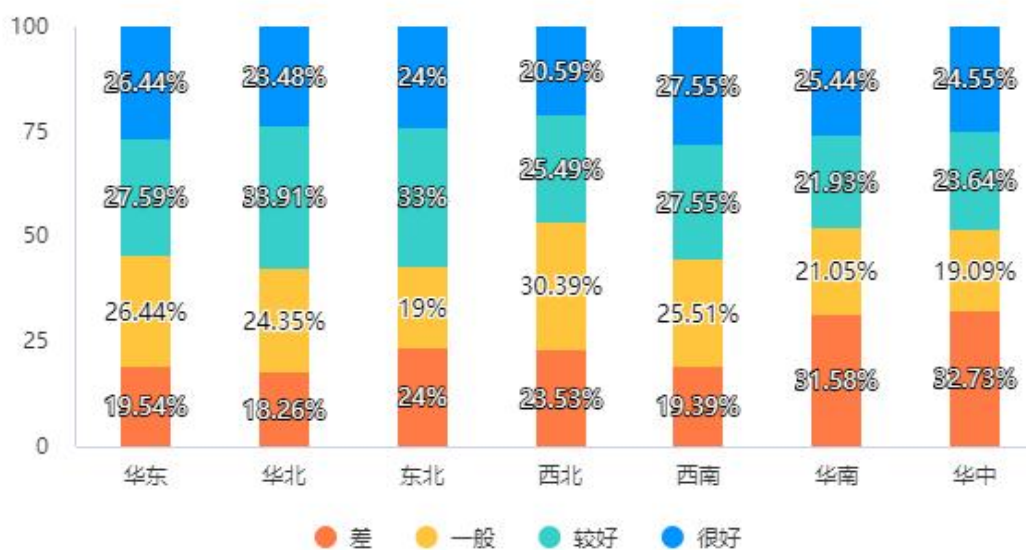
Figure4.1:Cross-analysis bar chart of statistics on the conservation of historic buildings and regions

X\Y	Very good	Good	Acceptable	Poor	Number
East China	26.44%	27.59%	26.44%	19.54%	87
North China	23.48%	33.91%	24.35%	18.26%	115
Northeast China	24%	33%	19%	24%	100
Northwest China	20.59%	25.49%	30.39%	23.53%	102
Southwest China	27.55%	27.55%	25.51%	19.39%	98
South China	25.44%	21.93%	21.05%	31.58%	114
Central China	24.55%	23.64%	19.09%	32.73%	110

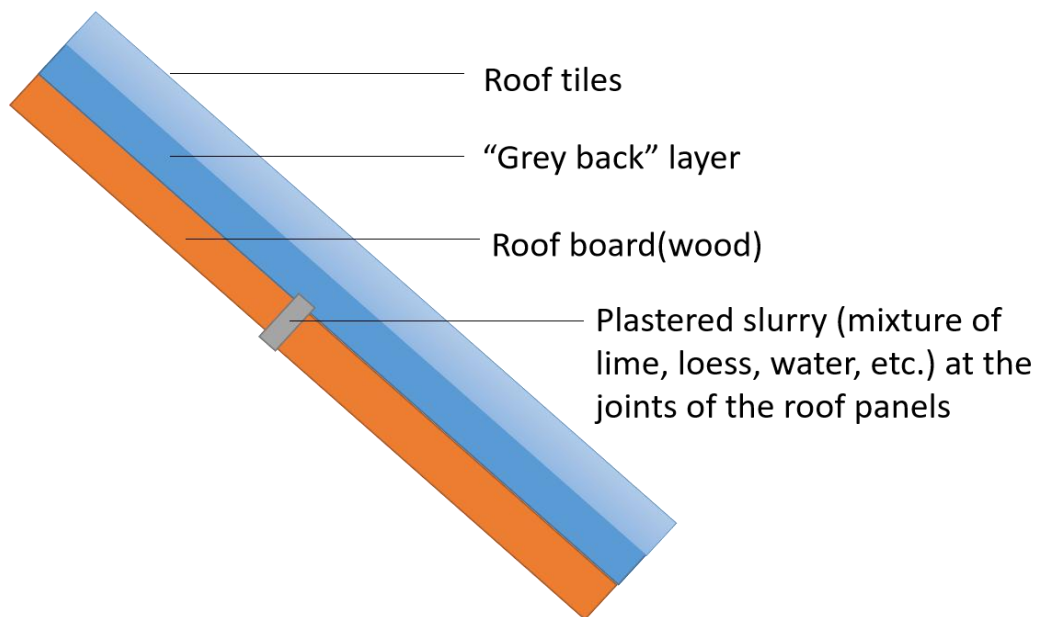
Below is a diagram of a traditional Chinese roofing project.

Figure4.2 :A traditional roofing practice (including waterproofing),gray back

The three historic buildings (sites) surveyed had one thing in common during the repair process. All have roofing works and are restored using traditional techniques.

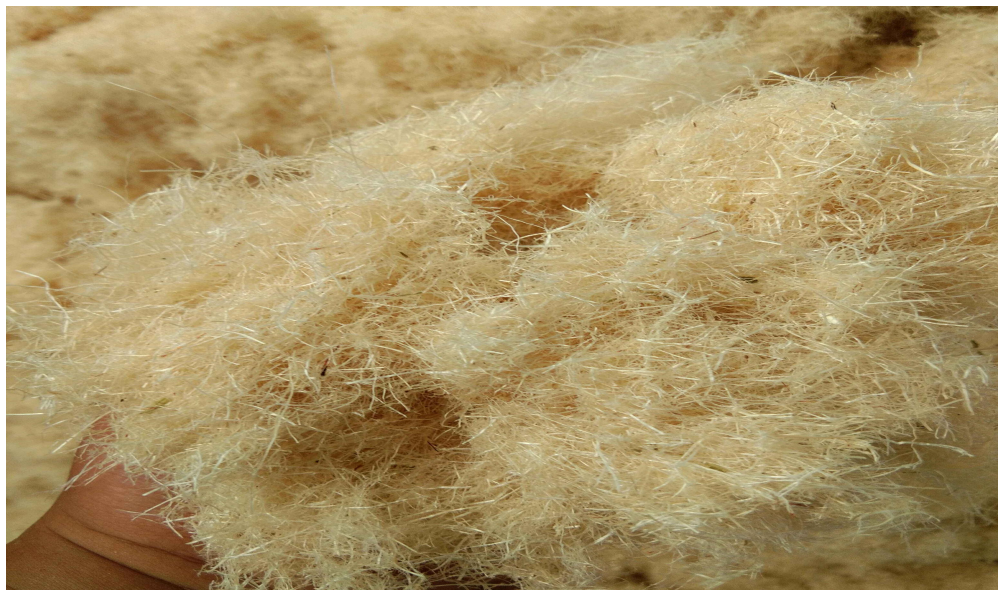
Figure4.3: One of the raw materials of slurry, plant fiber
(Source:<https://www.17yike.com/index.php/home/index/quan/id/597687379168.html>)

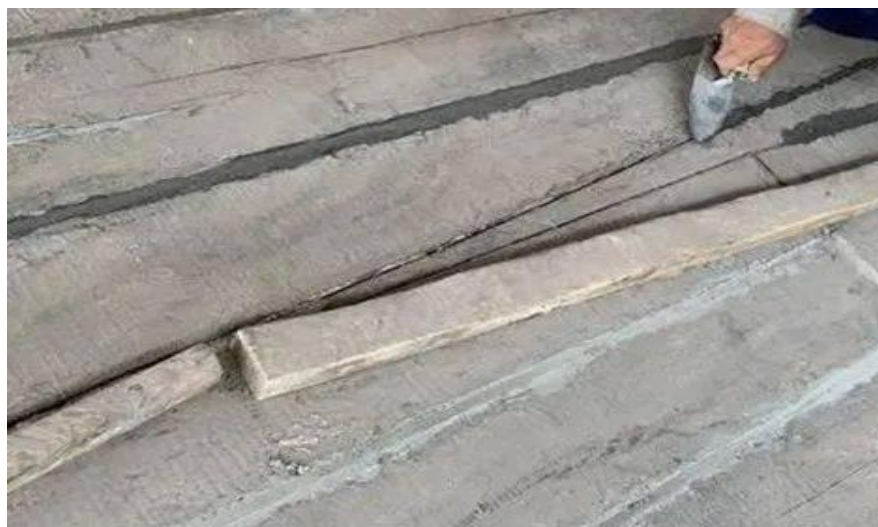
Figure4.4:Plastering at the joints of the roof panels
(Source:http://society.sohu.com/a/576510128_121106842)

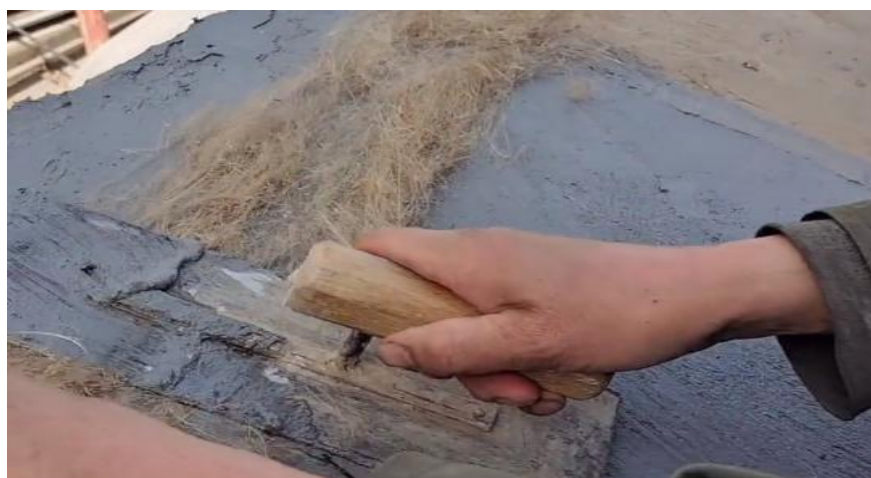
Figure4.5:The fibers are mixed with the slurry, compacted, and dried
(Source:https://www.bilibili.com/video/av502740649/?vd_source=d10cec5bb9d10ac220b34f0aca2add2c)

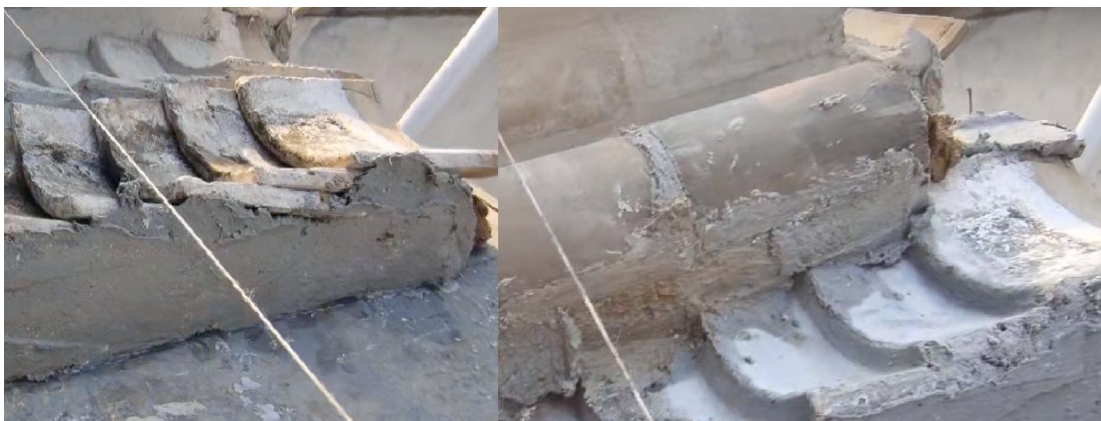
Figure 4.6: Install roofing tiles

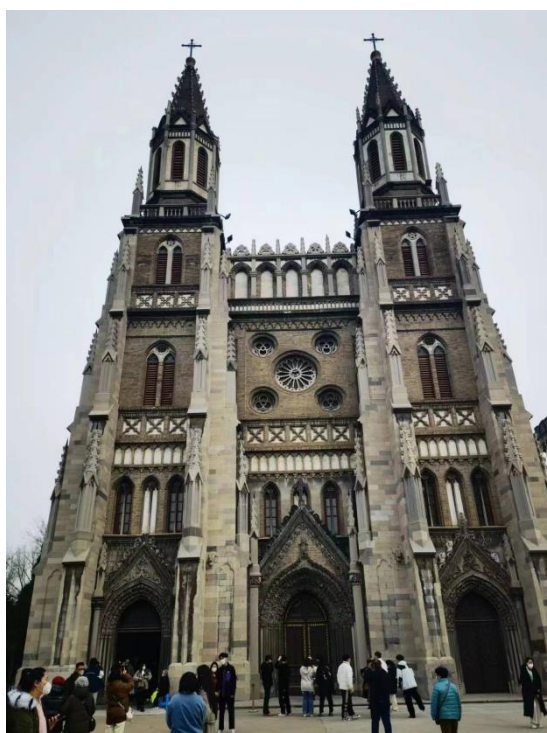
Figure: Hongjialou Cathedral

Name	Hongjialou Cathedral
Location	Licheng District, Jinan City, Shandong Province, China
Completion time	1905
Architectural style	Gothic Revival
Building material	The material is stone bricks, quarried in Jinan and belongs to limestone.
The original purpose of the building	Places of Christian activity
The value of the building	
Protected list: In 2009, it was announced by the State Council as a national key cultural relic protection unit.	
The main current use of the building: 1. Tourist attractions 2. Places of Christian activity	
Social benefits and others: Well-known attractions in Jinan; The largest Catholic church in North China

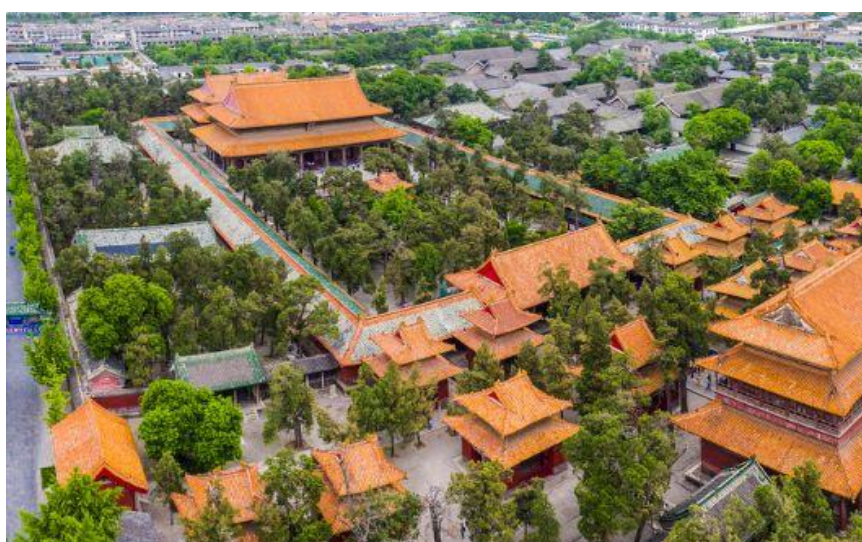
Name	Temple and Cemetery of Confucius and the Kong Family Mansion
Location	Qufu City,Shandong Province,China
Completion time	478BC----the earliest recorded More details are provided in report.
Building material	Wood, masonry
The original purpose of the building	Residences, sacrifices, tombs
The value of the building	
Protected list: State Priority Protected Sites in 1961; United Nations Educational, Scientific, and Cultural Organization(UNESCO),World Heritage List (https://whc.unesco.org/en/list/704/)	
The main current use of the building: Tourist attractions	
Social benefits and others: A representative of oriental architectural techniques, and has a deep historical connotation.

Figure:Temple and Cemetery of Confucius and the Kong Family Mansion
(Source:http://k.sina.com.cn/article_7042248789_p1a3c0305500100k1ot.html#/)

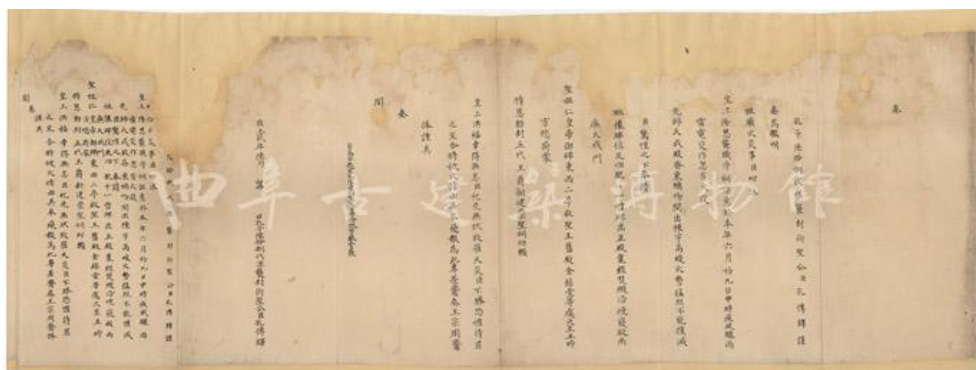
Figure: Report on the fire in the Temple of Confucius in 1723
(Source: <http://www.qfskgj.com/qfbwg/jycc/445.html>)

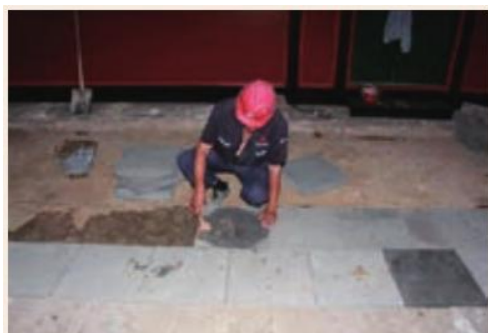
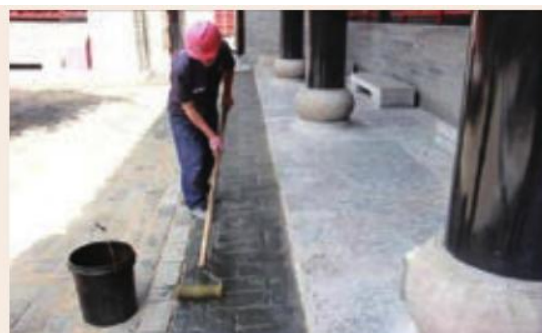
Inspection of pre-construction conditions		Upon examination, the following damage was found: The ground is fragmented; The apron is damaged and broken, part of the apron is missing, and the drainage function is lost; Part of the wall cracked and the brick cracks expanded
Process	Walls	Partial demolition of the wall; Cut out some bricks with severe salt-efflorescence. Shovel the hollow wall skin, clean the floating soil, nail the hemp and re-plaster.
	Floors	Remove the severely damaged floor tiles and gray soil bedding, redo the 3:7 lime-soil cushion and pave floor with bricks. Replacement of damaged bricks, bonding fractured stone components.
Strategies for achieving project objectives in terms of processes		When demolishing old walls, sort out, check and count old bricks that can continue to be used. It was rebuilt according to traditional practices. When laying new floor tiles, traditional materials are used, with a mixture of lime and loess as a bonding layer. After the laying is completed, apply 2 coats of tung-oil to the surface of the floor tiles.

后堂楼方砖地面铺墁

后堂楼散水地面钻生桐油

Figure: Laying floor tiles (left) ,applying tung-oil to floor tiles (right)
